Case Study 2008 Lake "Swan", Germany

Description

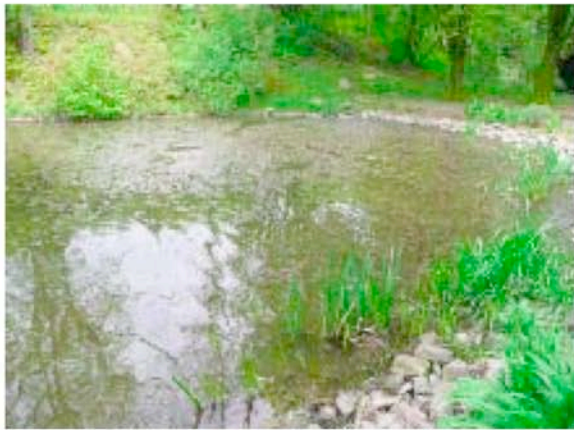
Situation before

The pond is suffering from high nutrient load due to countless water bird, fish and feeding by the visitors. The thick sludge layer on the bottom becomes anaerobic and generates bubbles. Scum and floating layers covering half of the lake surface, the water is turbid and smelly.

Following product mixture was applied one time:

6kg Pond Relief
6L OxiPlus TR35 Oxygenator

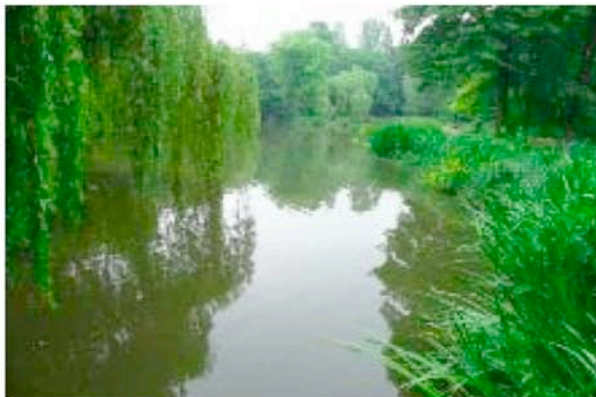
After 4 weeks, the scum, floating layers and smell were dissolved

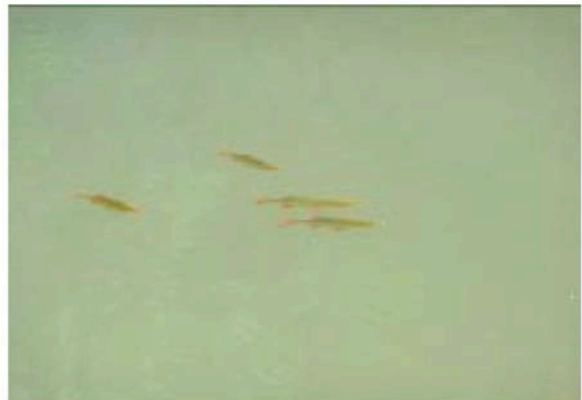
After 6 Weeks the water was clear.
